MHT No. <u>BA-2777</u>

MARYLAND INVENTORY OF HISTORIC BRIDGES HISTORIC BRIDGE INVENTORY MARYLAND STATE HIGHWAY ADMINISTRATION/MARYLAND HISTORICAL TRUST

SHA Bridge No. BC6502 Bridge name Dulaney Valley Road over Fitzhugh Run
LOCATION: Street/Road name and number [facility carried] Dulaney Valley Road
City/town Timonium Vicinity X
County Baltimore
This bridge projects over: Road Railway Water X Land
Ownership: State County Municipal X Other
HISTORIC STATUS:  Is the bridge located within a designated historic district? Yes NoX  National Register-listed district National Register-determined-eligible district  Locally-designated district Other
Name of district
BRIDGE TYPE: Timber Bridge: Beam Bridge: Truss -Covered Trestle Timber-And-Concrete
Stone Arch Bridge
Metal Truss Bridge
Movable Bridge: Swing Bascule Single Leaf Bascule Multiple Leaf Vertical Lift Retractile Pontoon
Metal Girder:  Rolled Girder:  Plate Girder:  Rolled Girder Concrete Encased:  Plate Girder:
Metal Suspension
Metal Arch
Metal Cantilever
Concrete X :  Concrete Arch Concrete Slab Concrete Beam X Rigid Frame Other Type Name

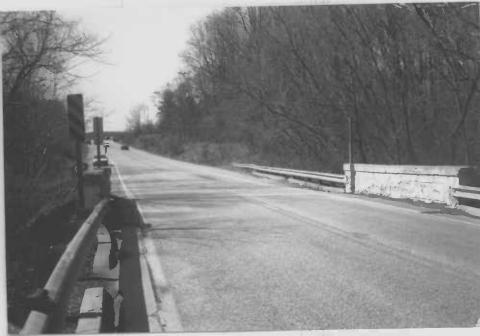
1. BA-2977 d Dulaney Valley Rol over Fitzhugh 3. Baltimore Citter, RUN 4 Eric Griffitts 5.3-97 6. MD SHPO 7. West Approach 8.10+ 6

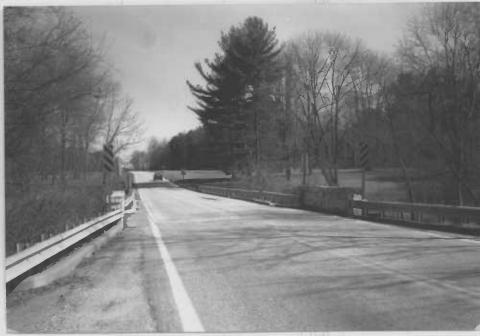
11 BA - 2777 a Dulaney Valley Robbier Fitz hugh 4. EVIC Grittetts (26502) 5.3-97 6. MD SHPO 7. EAST Approach 8. 20+6

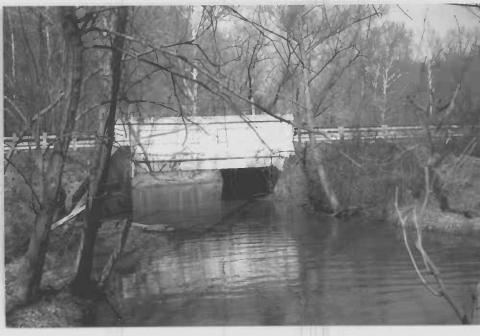
1. BA 2977 2. Dulancy Valley Rd over Fitzhigh 3. Baltimore Citter (BC650) 4. Eric Griffitts 5.3-97 6 md SHPO 7. South Elevation 8.30+6

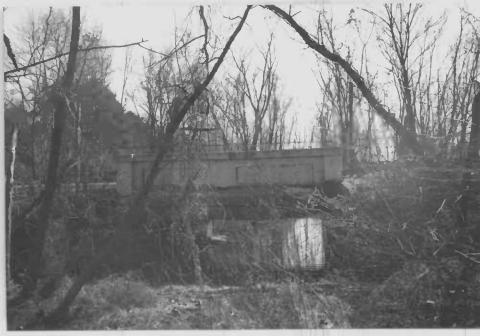
1, BA-0777 2. Dollaney Valley Robover Fitzhugh 3 Baltimore Cetter Run (BC6502) yiEric Griffitts 5.3.97 6. MO SHPE 9. North Elevation 8 5 Of 6

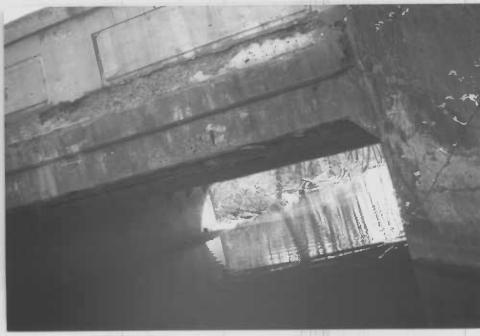
is important in structures which are common examples of their type. In addition, the structure must be in excellent condition. This concrete bridge has experienced considerable deterioration of the slab, beams, parapets, abutments, and wing walls.

The bridge retains much of the character-defining elements of its type, including the concrete T-beams, parapets, abutments, and wing walls. However, the integrity of these elements has been compromised by severe deterioration.

1. BA 2777 3. Bathmore City Run Be 1502) 4 & Rich Griffi 45 6. MD SHOO 7. Beams under Slab 8. 40+ 6
